## Change in Charleston's Built Environment: A Study of Building Footprints Comparing Primary Dwellings to Secondary Buildings in Harleston Village

A Thesis  
Presented to  
the Graduate Schools of  
Clemson University & College of Charleston

In Partial Fulfillment  
of the Requirements for the Degree  
Master of Science  
Historic Preservation

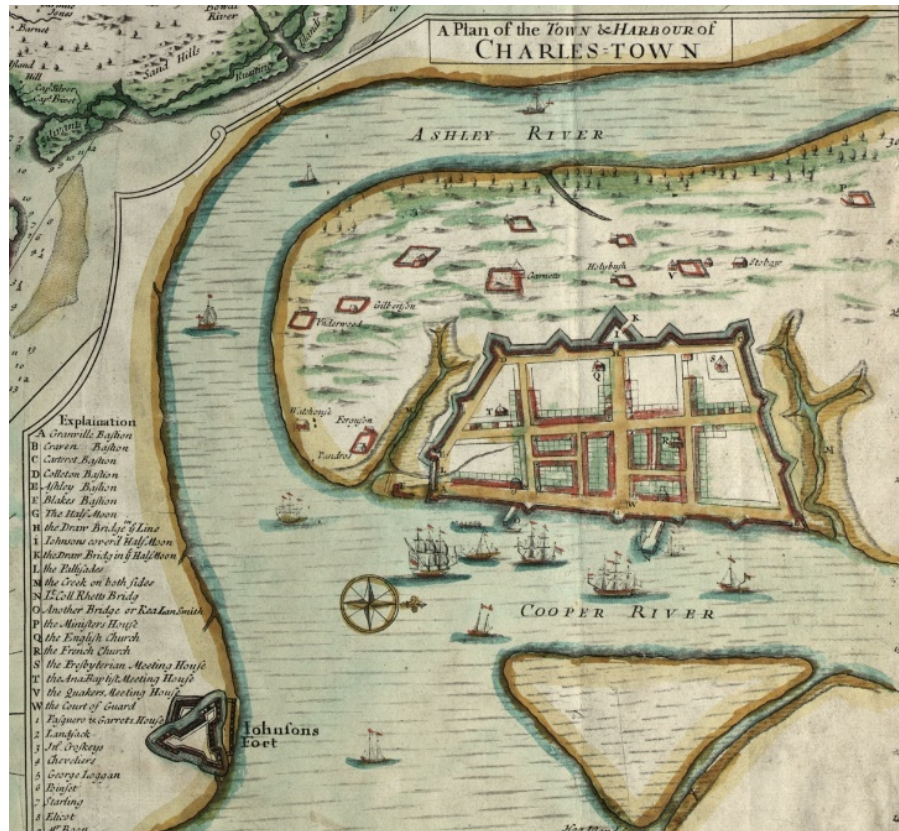
Figure 1.1: Crisp Map of Charles Town courtesy of SCIWAY. Illustrates Charleston in 1711 with fortification wall around settlement.

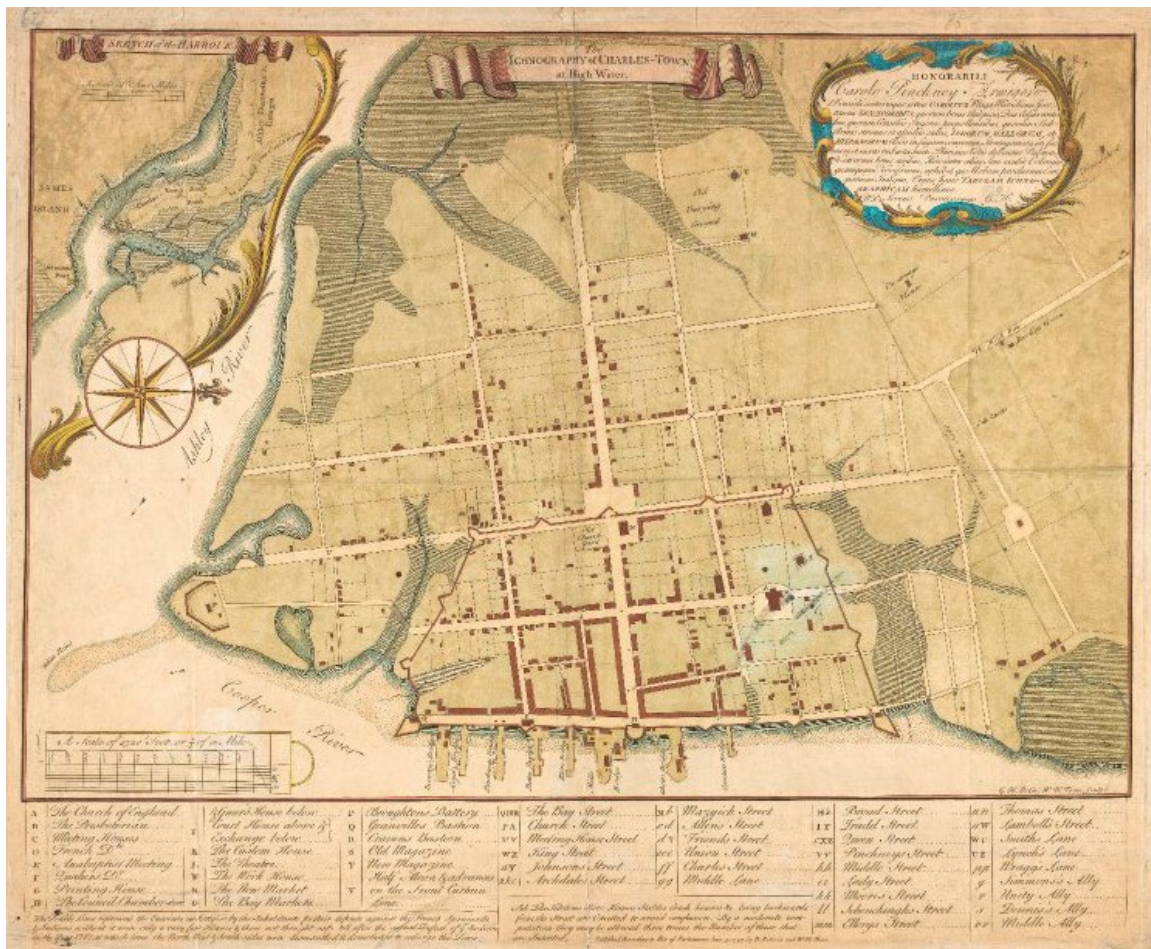
Figure 1.2: Ichnography of Charles Town at High Water from 1739 courtesy of SCIWAY. Illustrates Charleston's expansion beyond the completed 1704 walls.

The Iconography of Charles Town at High Water (1739), illustrates that there were buildings on land that would become Harleston Village. The area outside of the walled city is not as dense as found outside of the walls, showing the formulation of different neighborhoods and suburbs we know today. However, today these neighborhoods that appear as startups in 1739 are as dense now as the original location Charleston was established on. There are lot lines but there are no addresses attached to the lots and with 149 years between 1888 and 1739 it would be difficult to accurately discern what present lots changed. More than likely in the 149-year period between 1739 to 1888 Harleston Village saw a great amount of change in both land and buildings constructed.

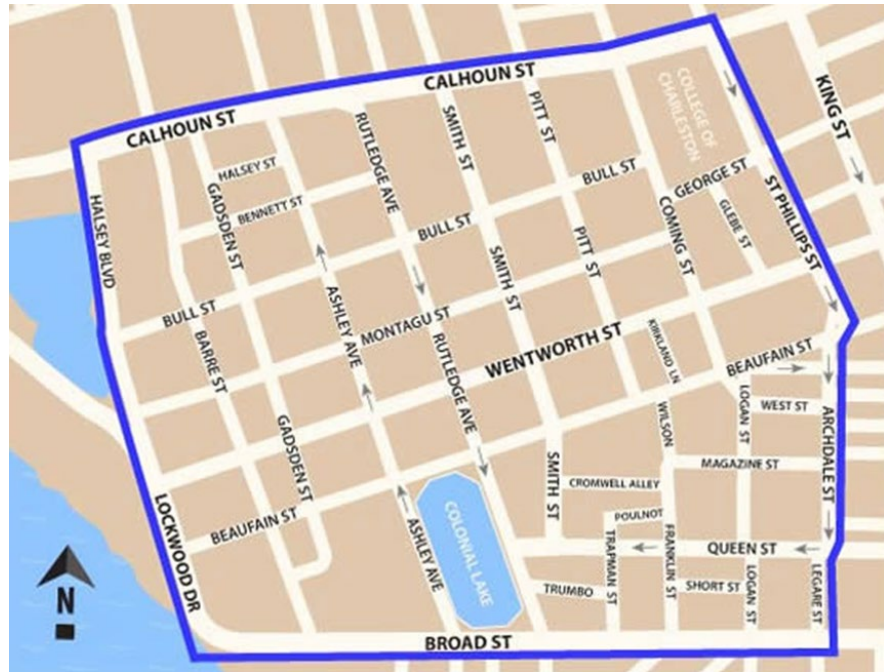
*Figure 1.3: Map of Harleston Village outlined in blue with street names.*

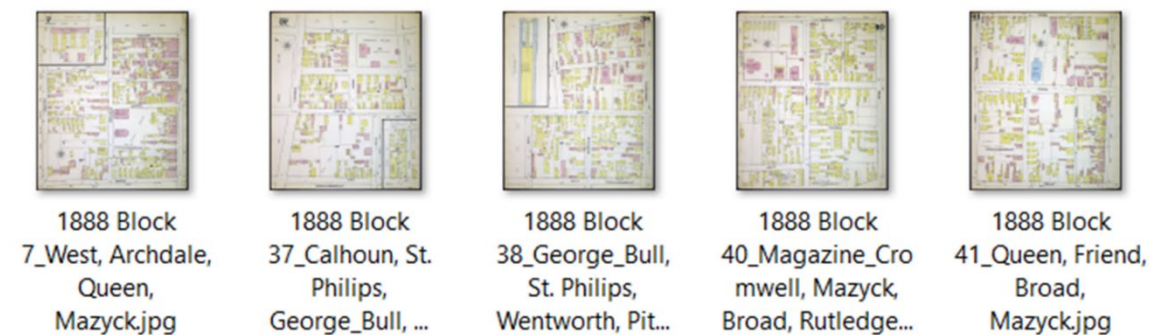
Sanborn Maps were collected using the Charleston County Public Library's database. For each Sanborn Map downloaded, the year, block number, and boundaries were recorded. For example, a Sanborn from 1955-1973 was recorded as 1955-1973 Block 37\_Calhoun, Smith, Bull, Ashley. When recording boundaries, first the northern, followed by the eastern, then southern and lastly western boundary were recorded. Boundaries for a majority of the blocks are streets. However, other boundaries are natural features such as undocumented land or the Ashley River. In other instances, an isolated block located on the fringes of Charleston is simply labeled a mill. For example, a map was recorded simply as 1888 Block 3\_Halsey's Saw Mill.

*Figure 3.2: Example of how a collection of Sanborn Maps from 1888 were recorded and saved.*

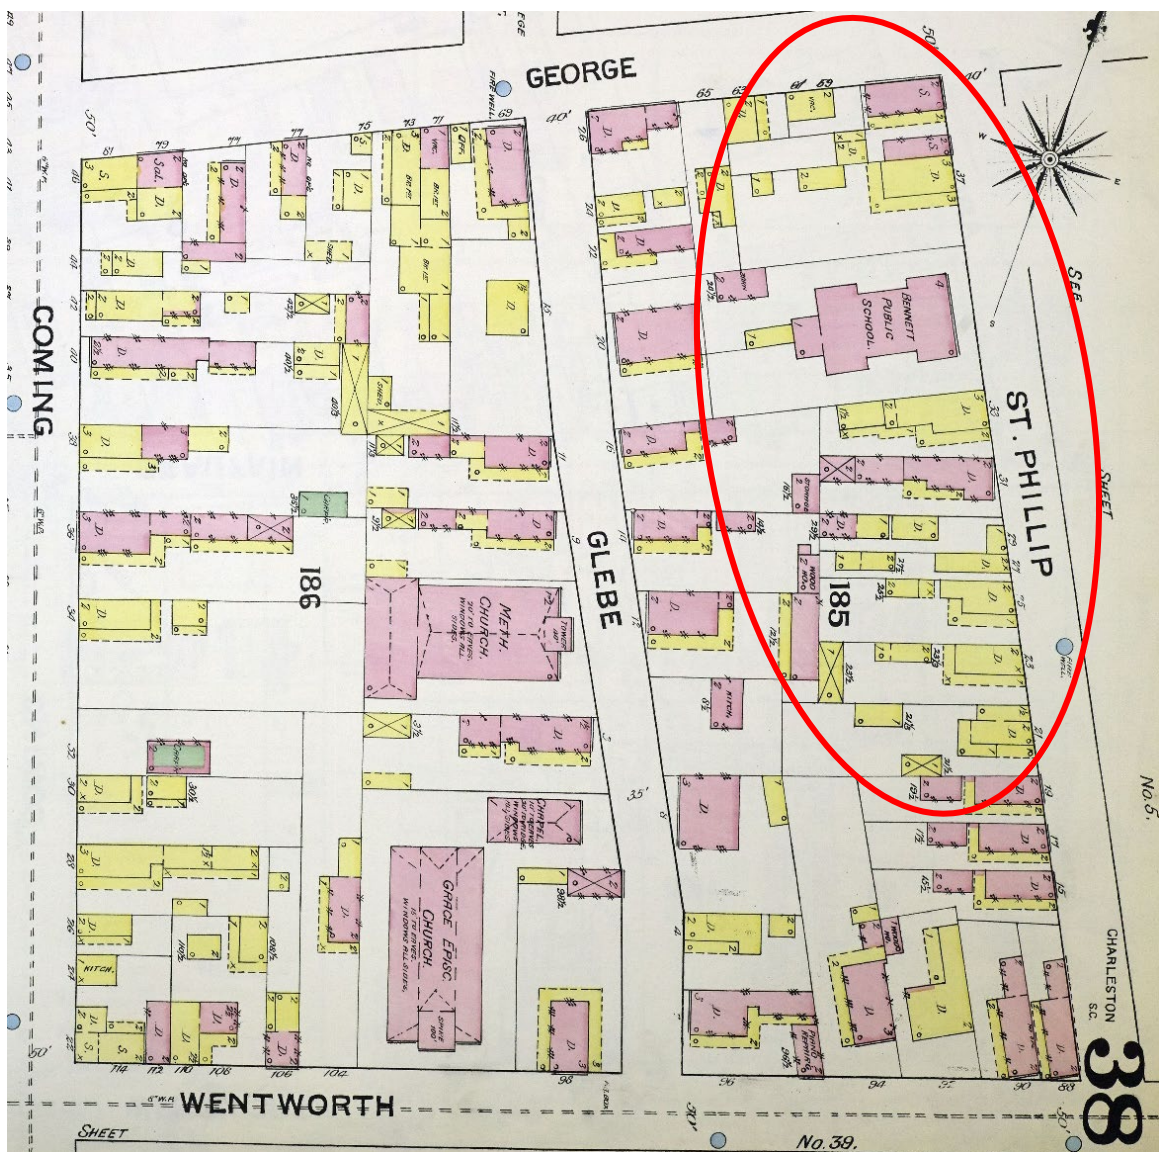
Figure 4.1: 1888 Sanborn Map showing roughly twelve individual property lots with primary and secondary buildings.

When analyzing the Sanborn Maps and walking around the neighborhood near the College of Charleston of the remaining buildings, few have clearly identifiable alterations from the public right of way. However, when walking around the neighborhood it became evident that alteration to main dwellings in the vicinity of the college came in the form of interior partitions. Mailboxes attached to secondary façades of main dwellings would have a numerical address identifier followed by an alphabetical identifier. The

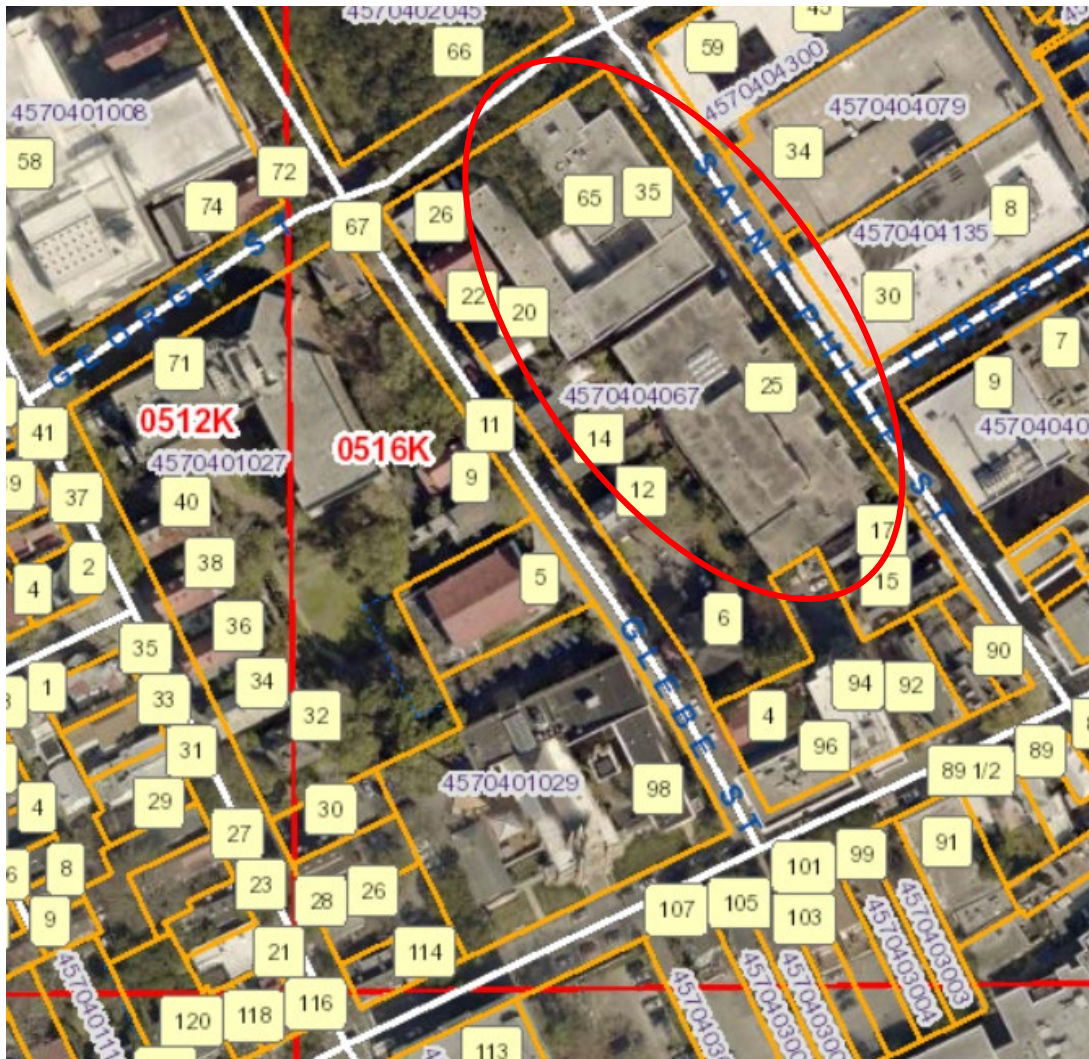
*Figure 4.2: Charleston Tax Parcel Map showing the roughly twelve properties with primary and secondary buildings have been replaced by monumental modern College of Charleston buildings.*

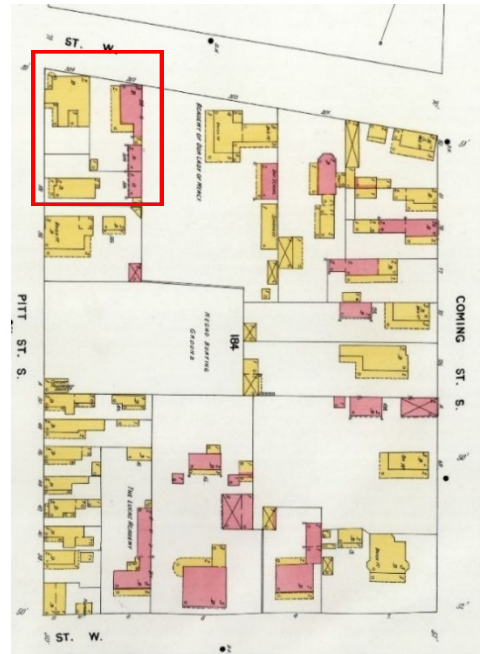
*Figure 4.4: 207 Calhoun property lot as seen on 1944 Sanborn Map. Lot broken up into three lots by 1944.*

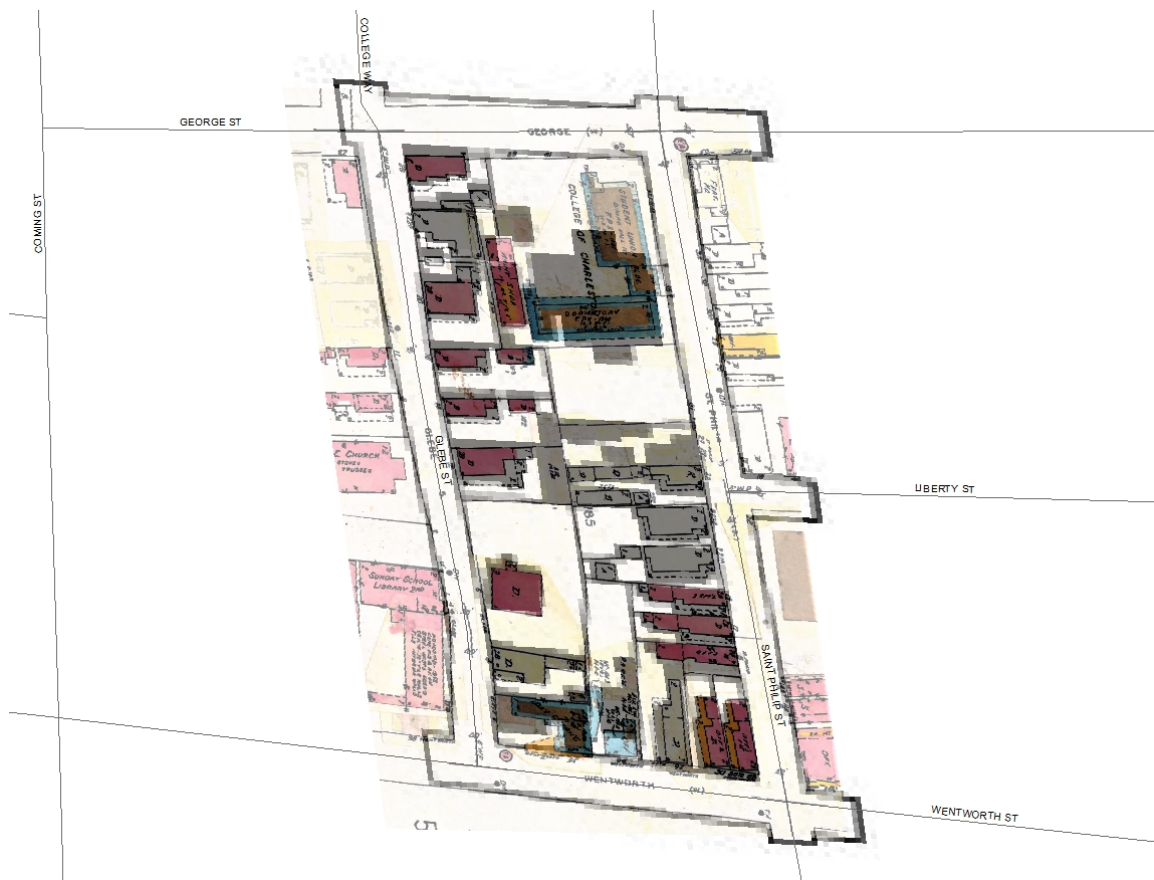
Block 1:

*Figure 4.5: City block bounded by George Street, Saint Philip Street, Wentworth Street and Glebe Street. 1902 Sanborn JPEG given a transparency value of 50%, overlaid over AutoCAD trace of 1888 Sanborn.*

*Figure 4.6: City block bounded by George Street, Saint Philip Street, Wentworth Street and Glebe Street. 1944 Sanborn JPEG given a transparency value of 50%, overlaid over AutoCAD trace of 1902 Sanborn.*

*Figure 4.7: City block bounded by George Street, Saint Philip Street, Wentworth Street and Glebe Street. 1955 Sanborn JPEG given a transparency value of 50%, overlaid over AutoCAD trace of 1944 Sanborn.*

*Figure 4.8: City block bounded by George Street, Saint Philip Street, Wentworth Street and Glebe Street. 1973 Sanborn JPEG given a transparency value of 50%, overlaid over AutoCAD trace of 1955 Sanborn.*

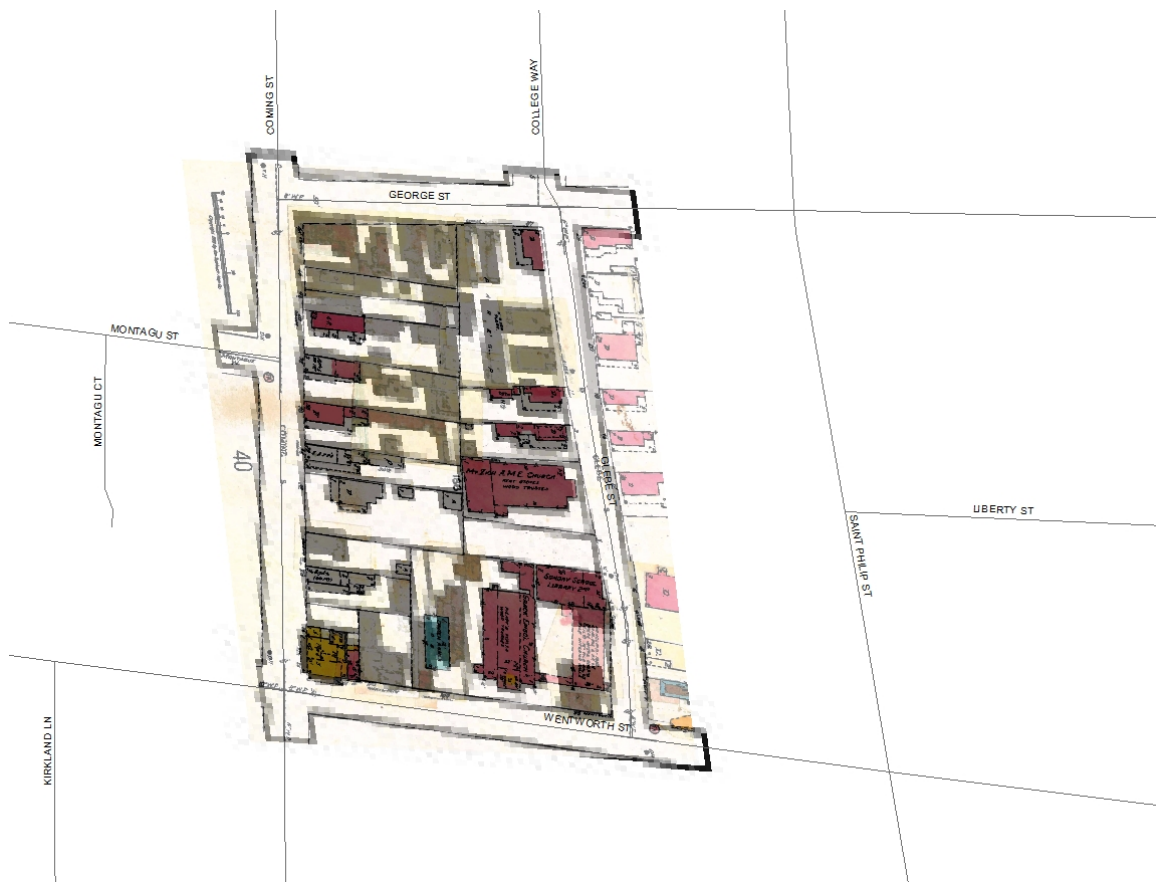
*Figure 4.9: City block bounded by George Street, Glebe Street, Wentworth Street and Coming Street. 1902 Sanborn JPEG given a transparency value of 50%, overlaid over AutoCAD trace of 1888 Sanborn.*

*Figure 4.10: City block bounded by George Street, Glebe Street, Wentworth Street and Coming Street. 1944 Sanborn JPEG given a transparency value of 50%, overlaid over AutoCAD trace of 1902 Sanborn.*

*Figure 4.11: City block bounded by George Street, Glebe Street, Wentworth Street and Coming Street. 1955 Sanborn JPEG given a transparency value of 50%, overlaid over AutoCAD trace of 1944 Sanborn.*

*Figure 4.12: City block bounded by George Street, Glebe Street, Wentworth Street and Coming Street. 1973 Sanborn JPEG given a transparency value of 50%, overlaid over AutoCAD trace of 1955 Sanborn.*

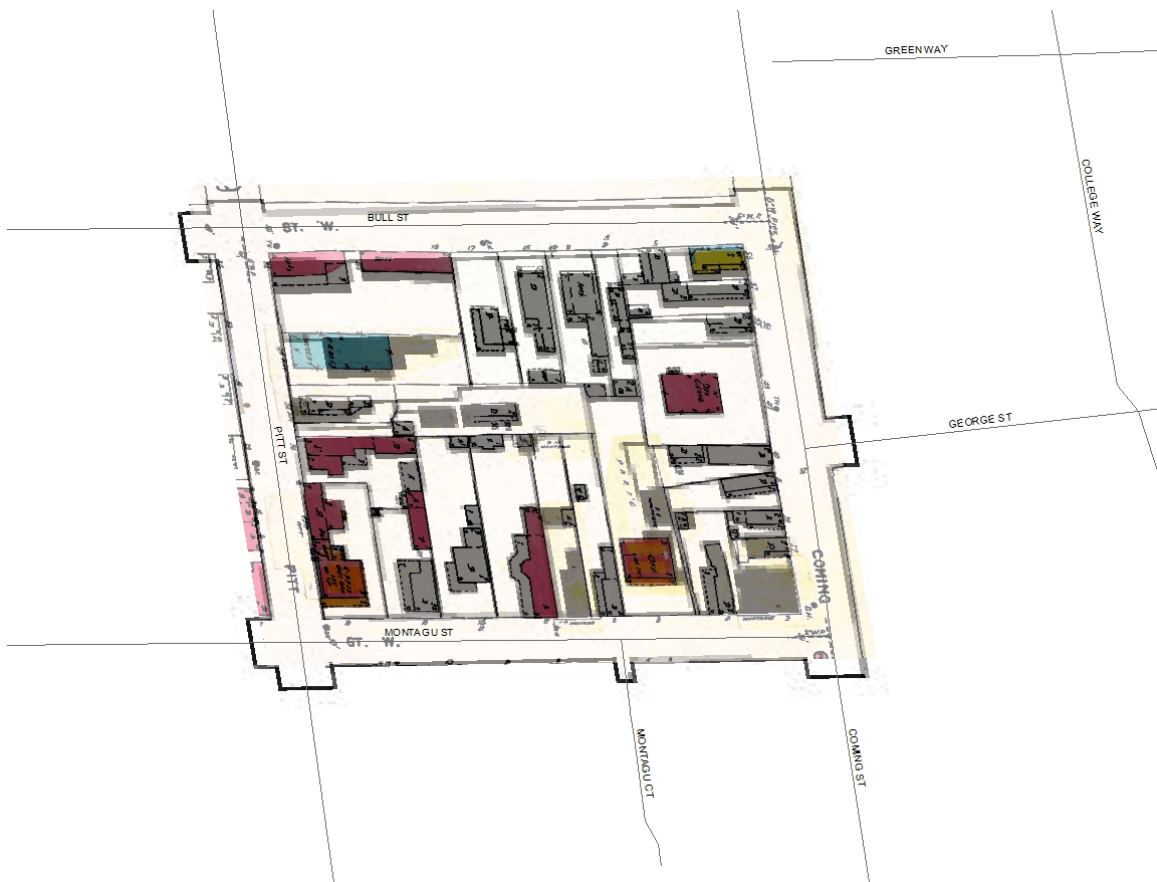
**Block 3:**

*Figure 4.13: City block bounded by Bull Street, Coming Street, Montague Street and Pitt Street. 1902 Sanborn JPEG given a transparency value of 50%, overlaid over AutoCAD trace of 1888 Sanborn.*

*Figure 4.14: City block bounded by Bull Street, Coming Street, Montague Street and Pitt Street. 1944 Sanborn JPEG given a transparency value of 50%, overlaid over AutoCAD trace of 1902 Sanborn.*

*Figure 4.15: City block bounded by Bull Street, Coming Street, Montague Street and Pitt Street. 1955 Sanborn JPEG given a transparency value of 50%, overlaid over AutoCAD trace of 1944 Sanborn.*

*Figure 4.16: City block bounded by Bull Street, Coming Street, Montague Street and Pitt Street. 1973 Sanborn JPEG given a transparency value of 50%, overlaid over AutoCAD trace of 1955 Sanborn.*

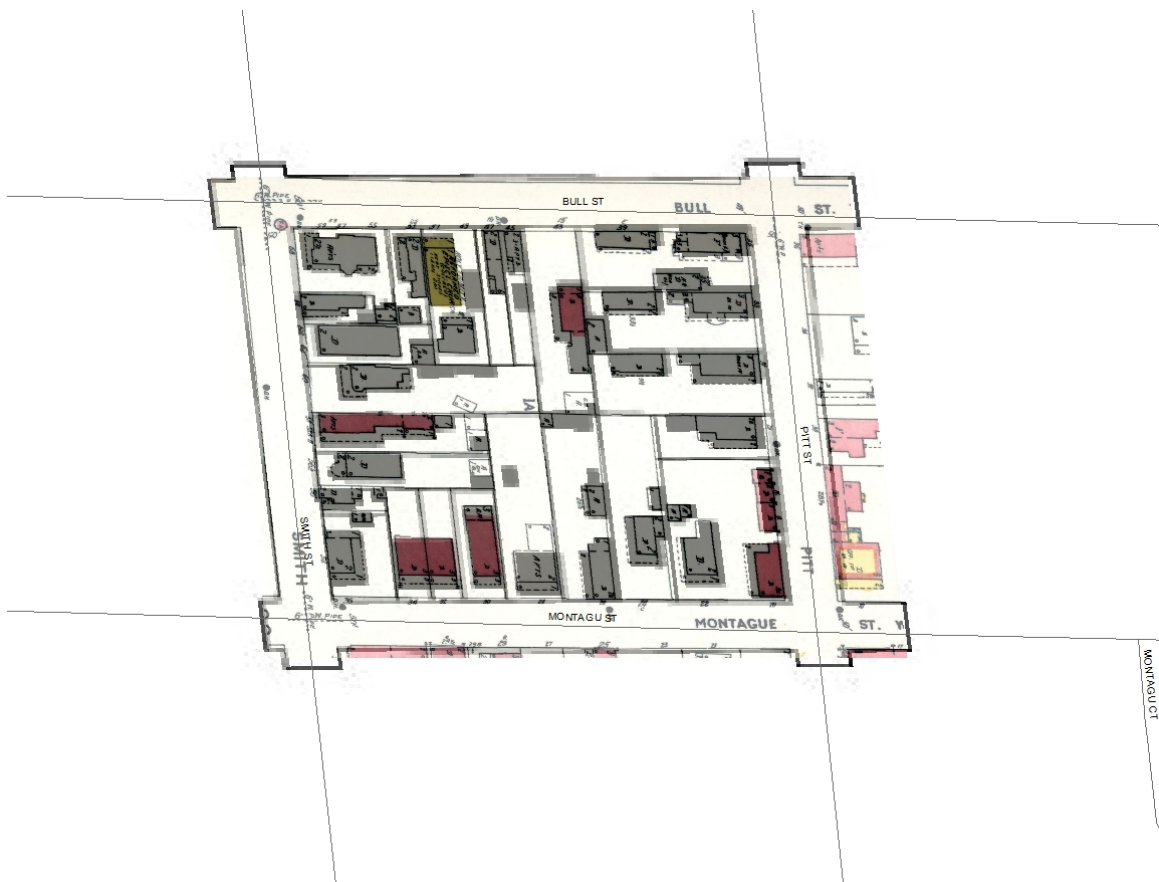
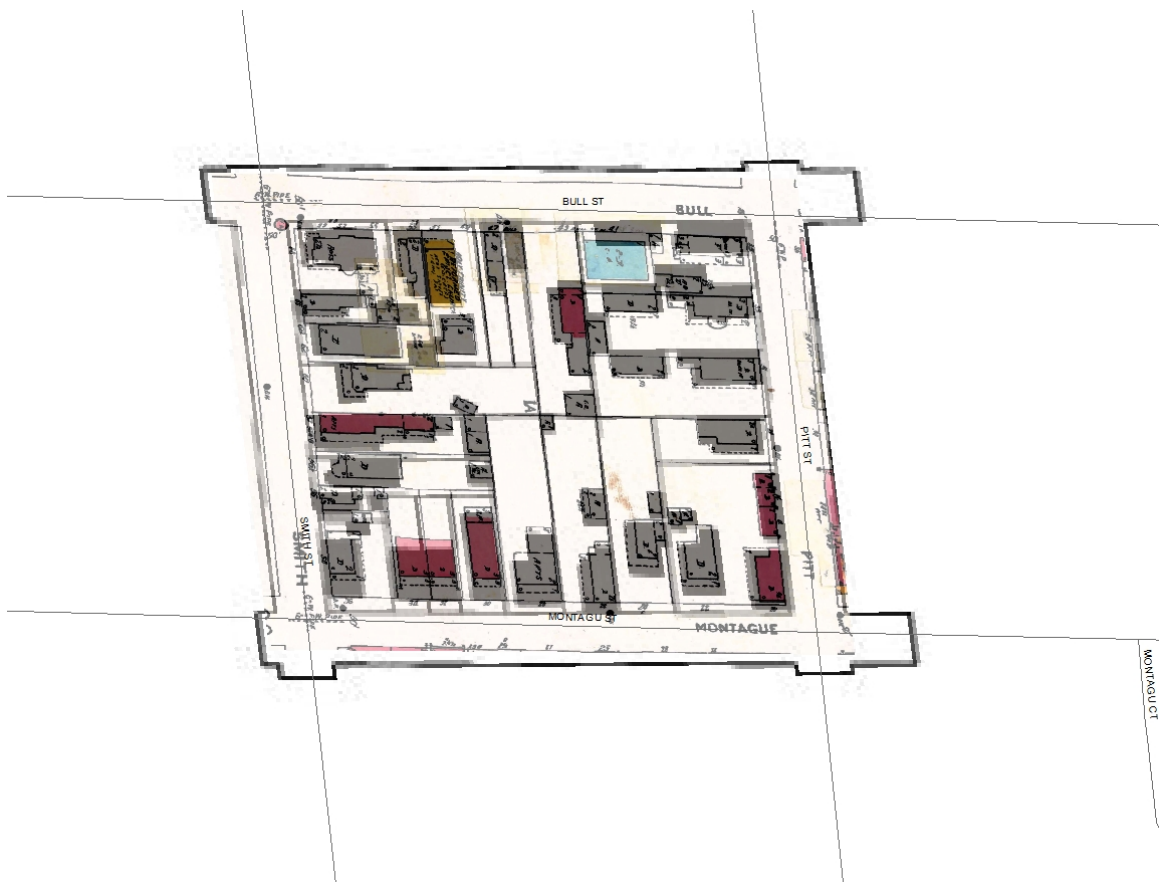
**Block 4:**

*Figure 4.17: City block bounded by Bull Street, Pitt Street, Montague Street and Smith Street. 1944 Sanborn JPEG given a transparency value of 50%, overlaid over AutoCAD trace of 1902 Sanborn.*

*Figure 4.18: City block bounded by Bull Street, Pitt Street, Montague Street and Smith Street. 1955 Sanborn JPEG given a transparency value of 50%, overlaid over AutoCAD trace of 1944 Sanborn.*

*Figure 4.19: City block bounded by Bull Street, Pitt Street, Montague Street and Smith Street. 1973 Sanborn JPEG given a transparency value of 50%, overlaid over AutoCAD trace of 1955 Sanborn.*

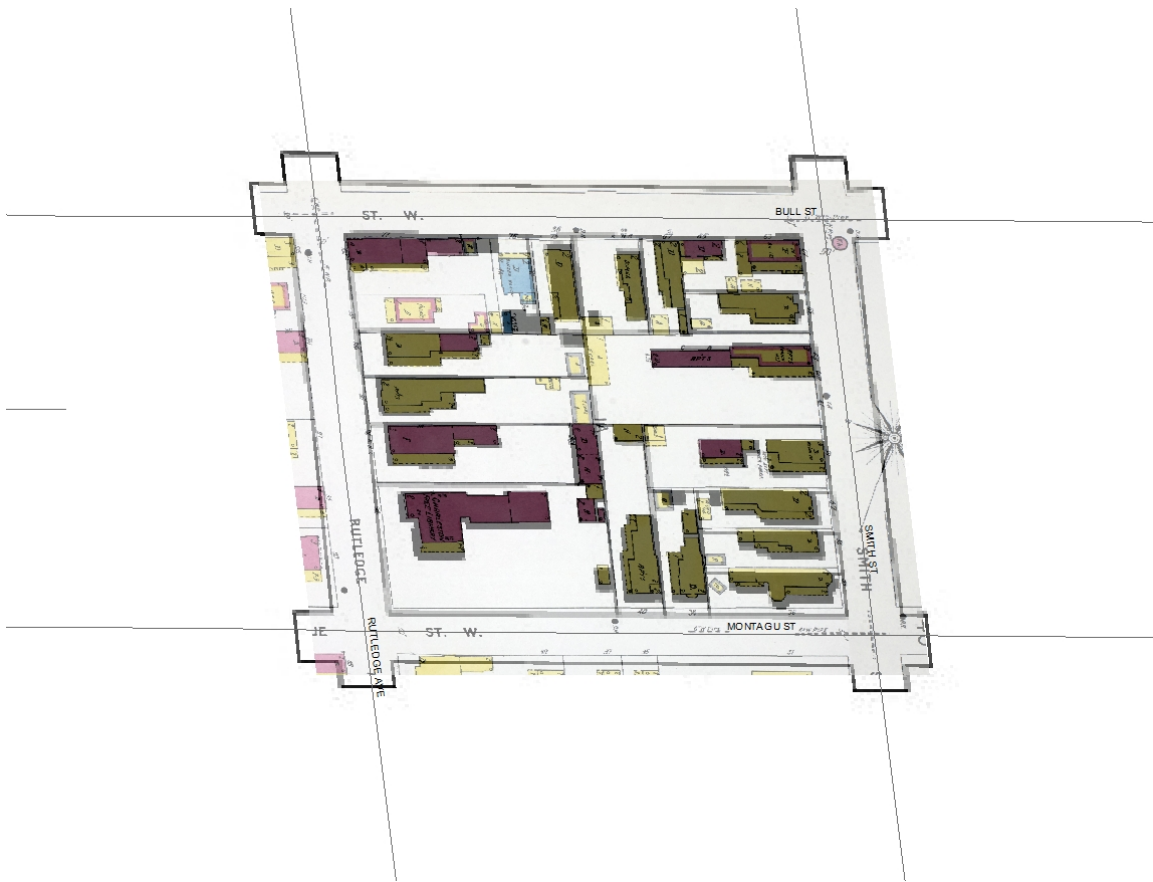
**Block 5:**

*Figure 4.20: City block bounded by Bull Street, Smith Street, Montague Street and Rutledge Avenue. 1944 Sanborn JPEG given a transparency value of 50%, overlaid over AutoCAD trace of 1902 Sanborn.*

*Figure 4.21: City block bounded by Bull Street, Smith Street, Montague Street and Rutledge Avenue. 1955 Sanborn JPEG given a transparency value of 50%, overlaid over AutoCAD trace of 1944 Sanborn.*

*Figure 4.22: City block bounded by Bull Street, Smith Street, Montague Street and Rutledge Avenue. 1973 Sanborn JPEG given a transparency value of 50%, overlaid over AutoCAD trace of 1955 Sanborn.*

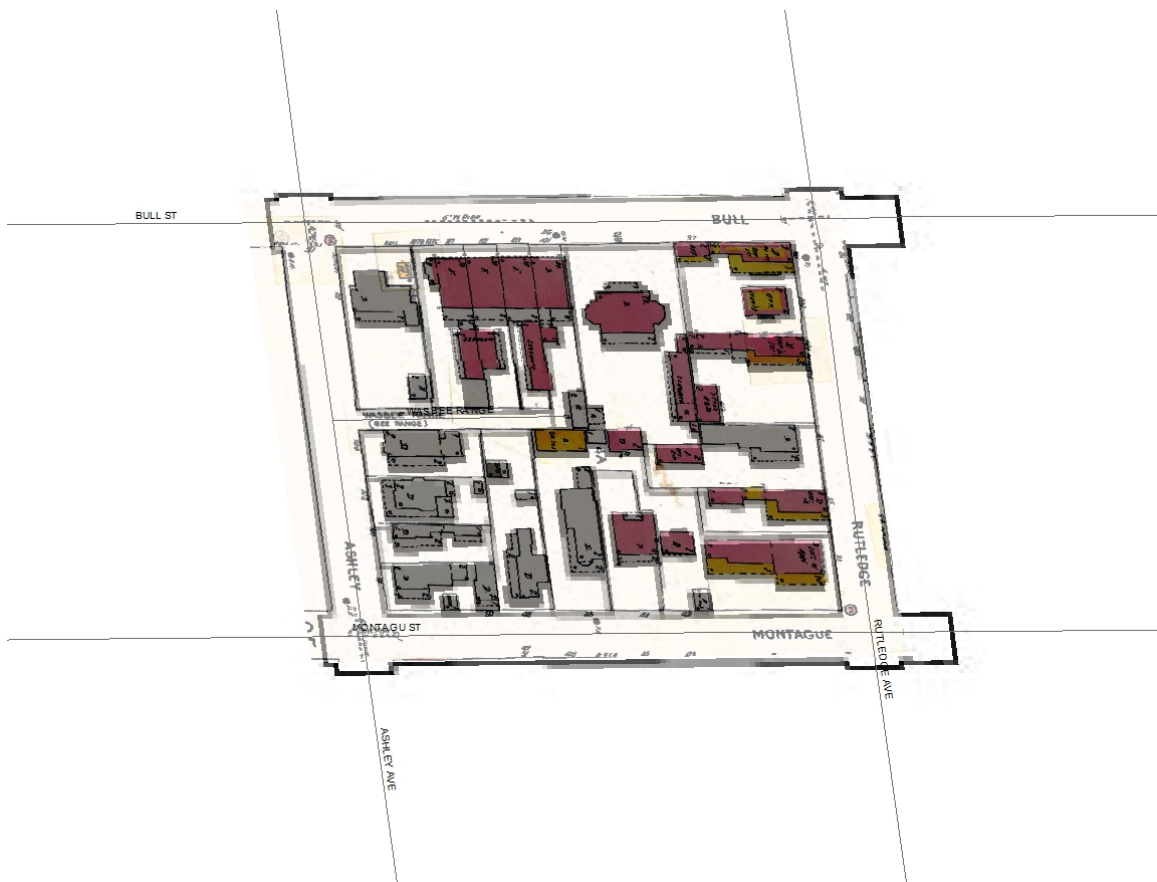
**Block 6:**

*Figure 4.23: City block bounded by Bull Street, Rutledge Avenue, Montague Street and Ashley Avenue. 1944 Sanborn JPEG given a transparency value of 50%, overlaid over AutoCAD trace of 1902 Sanborn.*

*Figure 4.24: City block bounded by Bull Street, Rutledge Avenue, Montague Street and Ashley Avenue. 1955 Sanborn JPEG given a transparency value of 50%, overlaid over AutoCAD trace of 1944 Sanborn.*

*Figure 4.25: City block bounded by Bull Street, Rutledge Avenue, Montague Street and Ashley Avenue. 1973 Sanborn JPEG given a transparency value of 50%, overlaid over AutoCAD trace of 1955 Sanborn.*

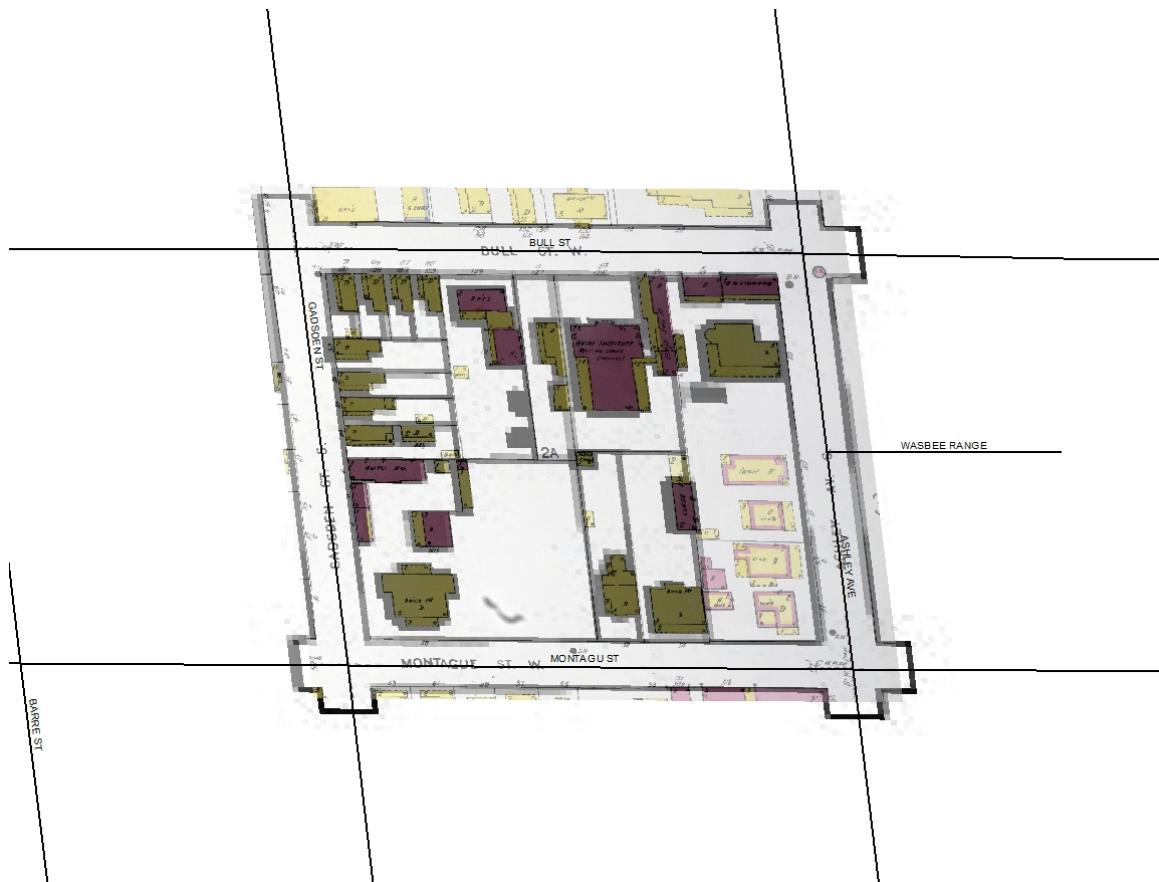
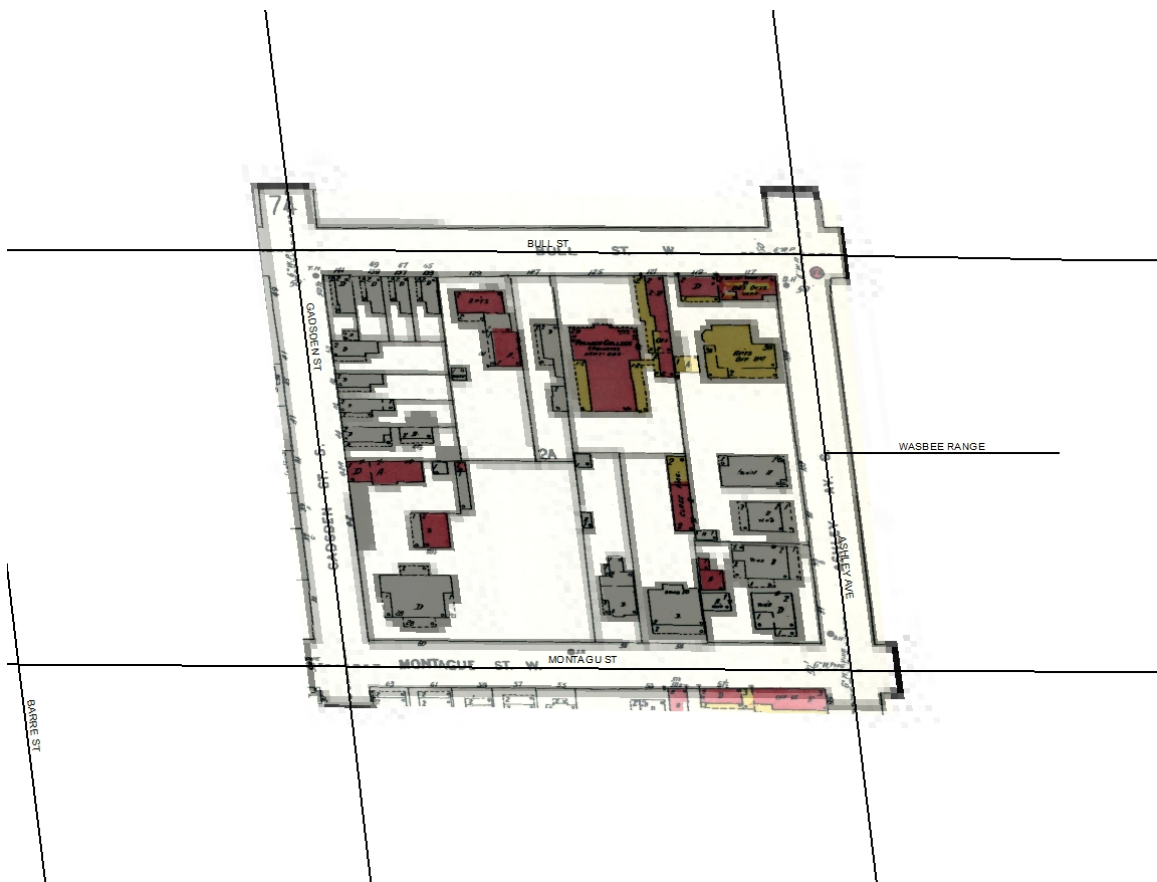
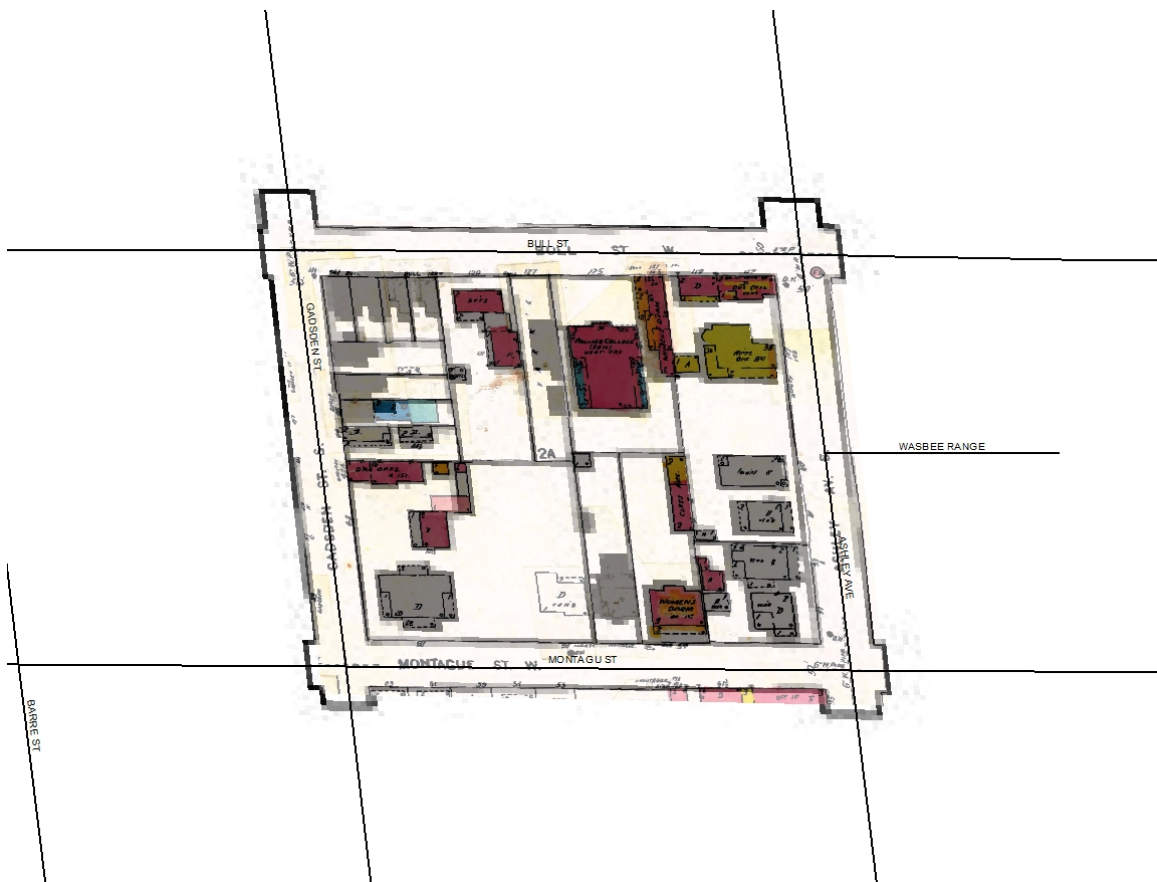
**Block 7:**

*Figure 4.26: City block bounded by Bull Street, Ashley Avenue, Montague Street and Gadsden Street. 1944 Sanborn JPEG given a transparency value of 50%, overlaid over AutoCAD trace of 1902 Sanborn.*

Figure 4.27: City block bounded by Bull Street, Ashley Avenue, Montague Street and Gadsden Street. 1955 Sanborn JPEG given a transparency value of 50%, overlaid over AutoCAD trace of 1944 Sanborn.

Figure 4.28: City block bounded by Bull Street, Ashley Avenue, Montague Street and Gadsden Street. 1973 Sanborn JPEG given a transparency value of 50%, overlaid over AutoCAD trace of 1955 Sanborn.

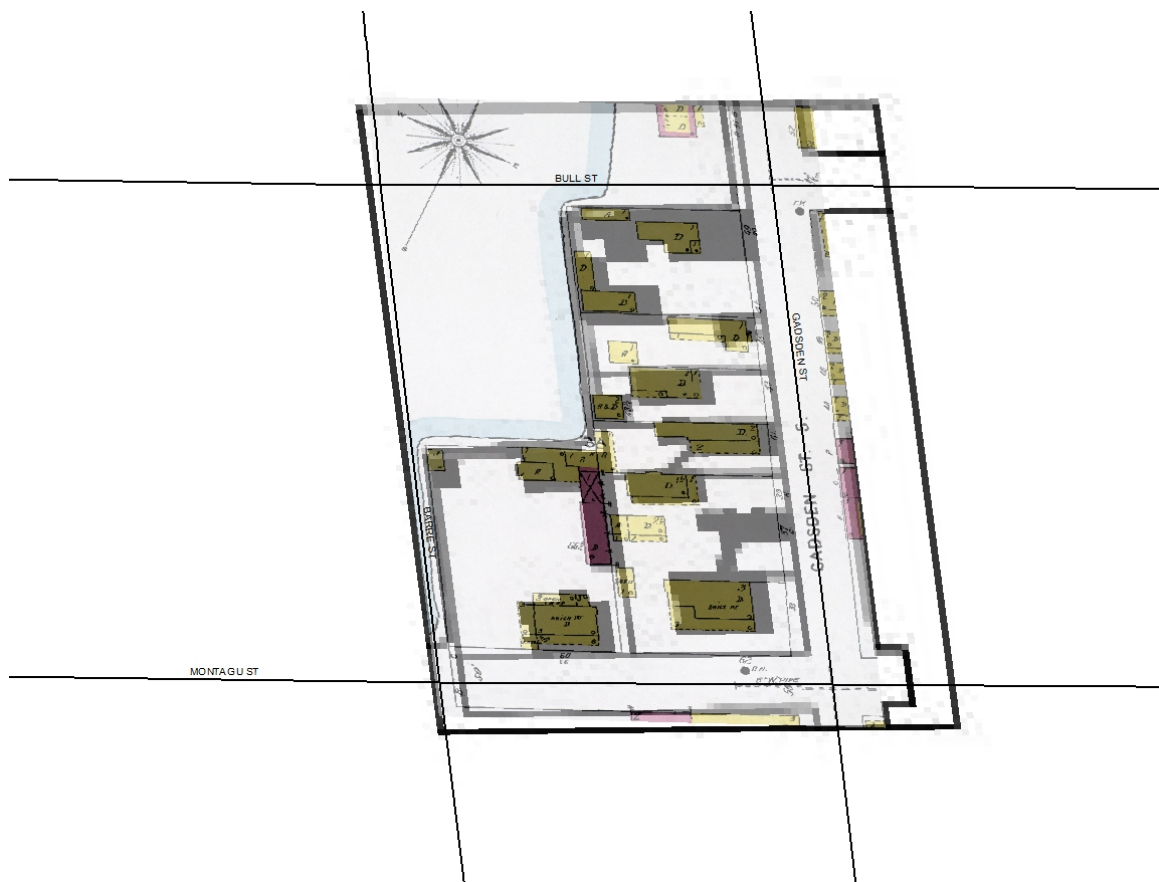
**Block 8:**

*Figure 4.29: City block bounded by Bull Street, Gadsden Street, Montague Street and Barre Street. 1944 Sanborn JPEG given a transparency value of 50%, overlaid over AutoCAD trace of 1902 Sanborn.*

*Figure 4.30: City block bounded by Bull Street, Gadsden Street, Montague Street and Barre Street. 1955 Sanborn JPEG given a transparency value of 50%, overlaid over AutoCAD trace of 1944 Sanborn.*

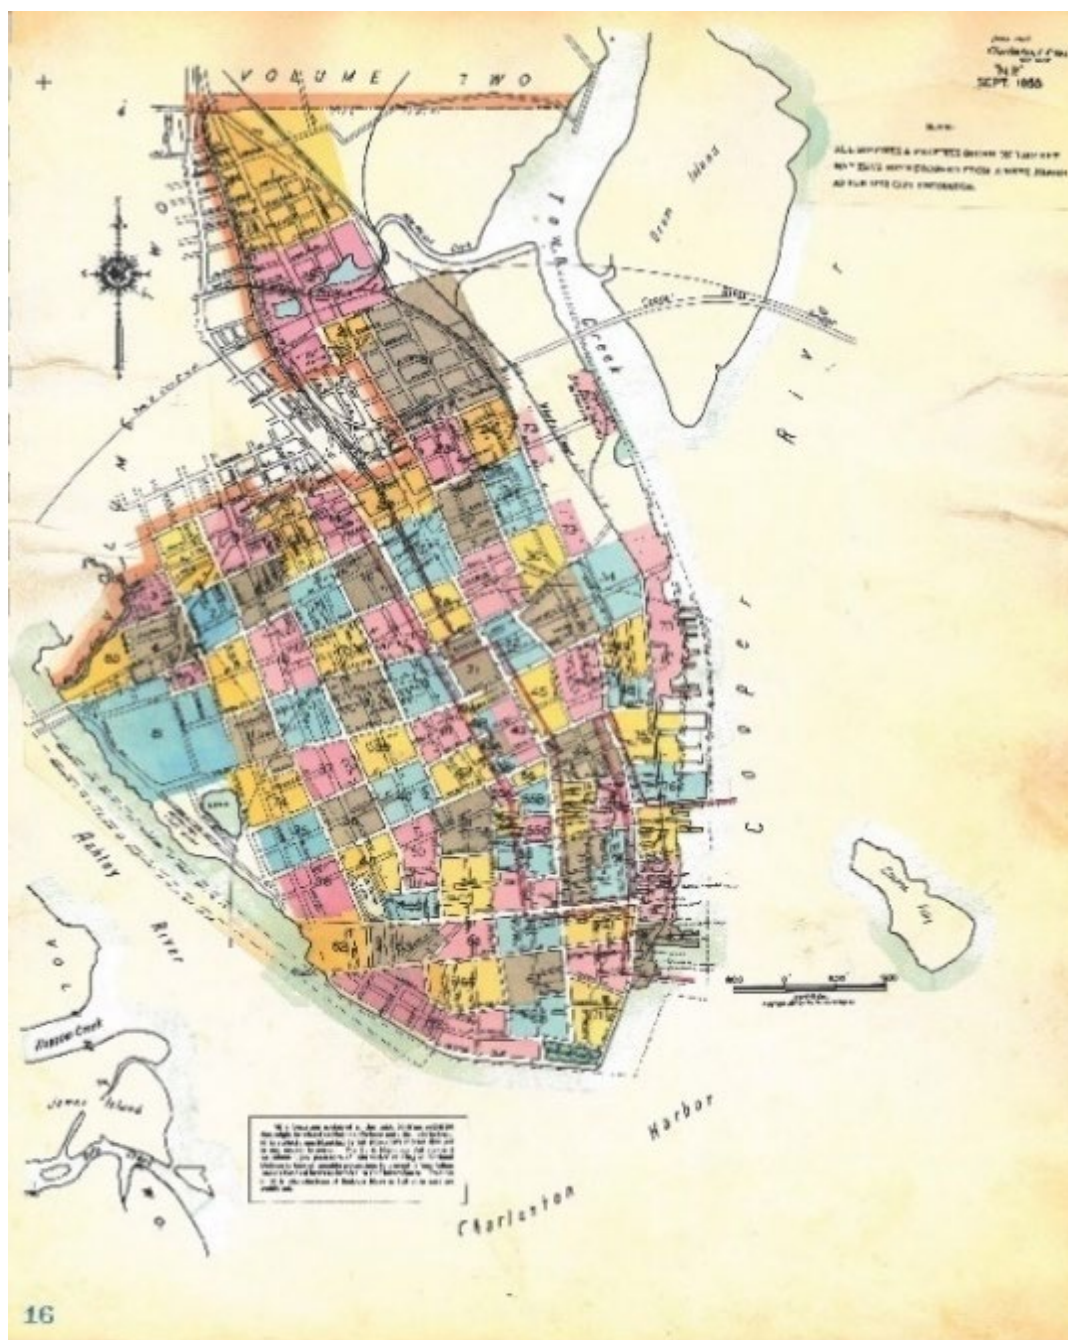
Figure 4.39: 1895 Sanborn showing growth of Charleston Peninsula.
